Akron Children's Hospital

Acoustic Design By:

The D.H. Kaiser Co.
P.O. Box 21035
Canton, Ohio 44701

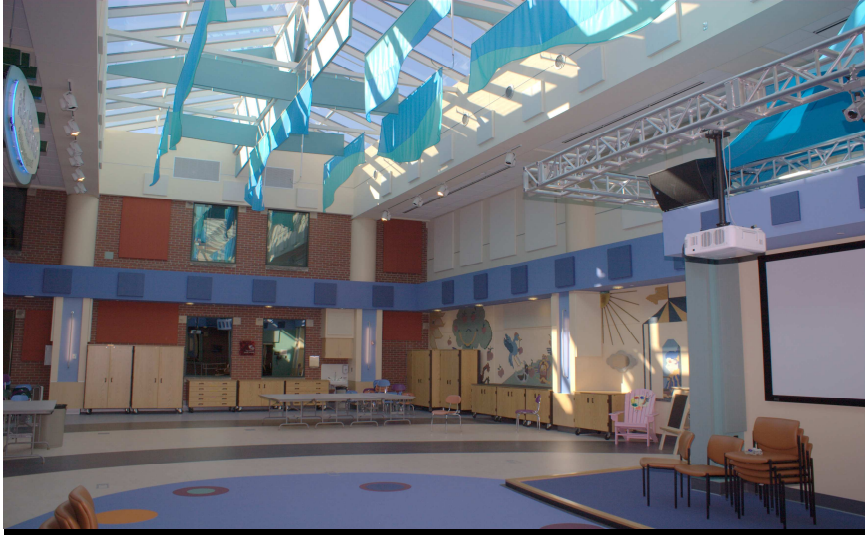
THIS FACILITY, BUILT TO ACCOMMODATE BOTH MUSIC AND ART THERAPY, COULD NOT FULLY PERFORM ITS INTENDED PURPOSE. UPON INITIAL TESTING, IT WAS FOUND THAT THERE WAS A HIGH REVERB TIME THAT DISTORTED SPEECH AT MID FREQUENCIES.. THIS ROOM ALSO HAD AN UNEVEN DISTRIBUTION OF SOUND ABSORBING MATERIALS AND LACKED PROPER SOUND DIFFUSTION WHICH MADE CONVERSATION UNCLEAR AT DIFFERENT LOCATIONS IN THE ROOM. BECAUSE THERE WERE TO BE MANY ACTIVITIES GOING ON AT ONE TIME, IT WAS NECESSARY TO INSTALL BAFFLES AND WALL SOUND ABSORBERS AT APPROPRIATE LOCATIONS TO BETTER CONTAIN THE SOUND FOR THAT PARTICULAR ACTIVITY. AS A RESULT OF THE INSTALLATION, CONVERSATION AND MUSIC COULD BE HEARD CLEARLY WITH A FLAT REVERB TIME WITH A GENTLE RISE BELOW 500 HZ TO ADD FULLNESS AND WARMTH TO SOUNDS.

Volume: 665,164 cubic feet
Reverberation Time: 1.84 Seconds (500 Hz)
Acoustic Function Criteria:
Music/Art Therapy
